### Case **Study**

# Trenchless Pipeline Renewal with SIMONA® SPC RC-Line Pipes

Renewal of the existing drinking water transport and supply pipeline in Baden, Switzerland

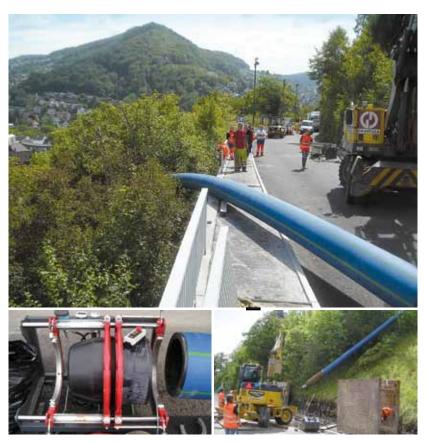
After the SIMONA® SPC RC pipe had been welded to the towing head it had to overcome a distance of 72 m and a maximum incline of 80%.
